Manhole Inspection Summary

Manhole # S13II2008MH

Location Address: **2118 NORTHCLIFF DR**

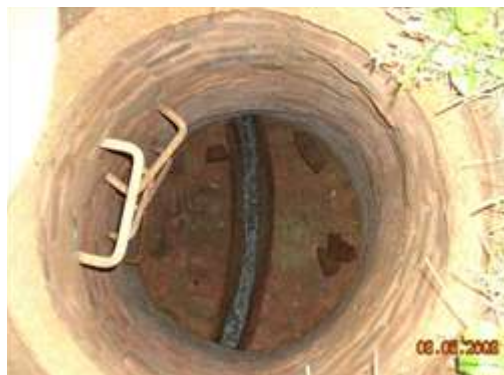
Top View

Adjustment and Barrel infiltration.
Corroded steps. Evidence of surcharge -
Bench debris.

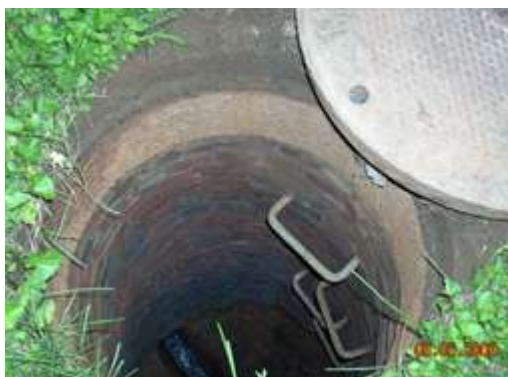
Defect

Frame leaks. Adjustment and Barrel
infiltration - other side.

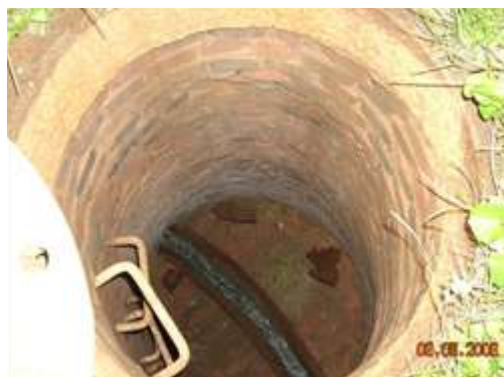
Defect

Frame leaks. Adjustment and Barrel
infiltration.

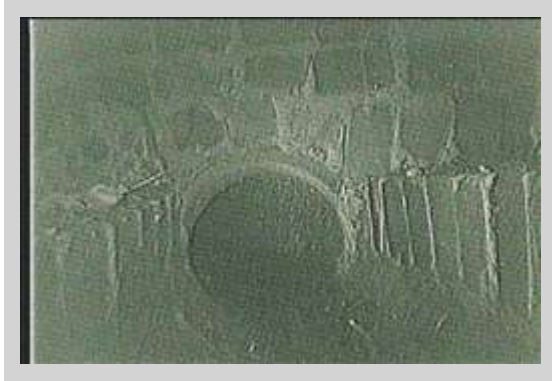
8 in. Circular Gravity Sewer Pipe Out @ 12 O'Clock

Invert Depth: **10.33** (ft.) Flow Characteristics: **Slow**

Infiltration: **None** Pipe Seal Cond: **Unknown**

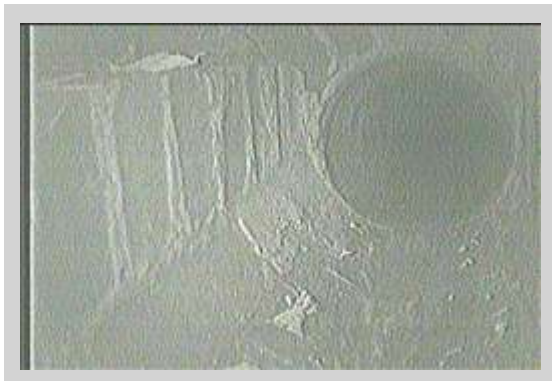
8 in. Circular Gravity Sewer Pipe In @ 7 O'Clock

Invert Depth: **10.01** (ft.) Flow Characteristics: **Slow**

Infiltration: **Evidence** Pipe Seal Cond: **Unknown**
